ROCK-SLOPE FAILURE IN PARTS OF THE SCOTTISH HIGHLANDS

GRAHAM HOLMES, B.Sc.

University of Edinburgh

1984

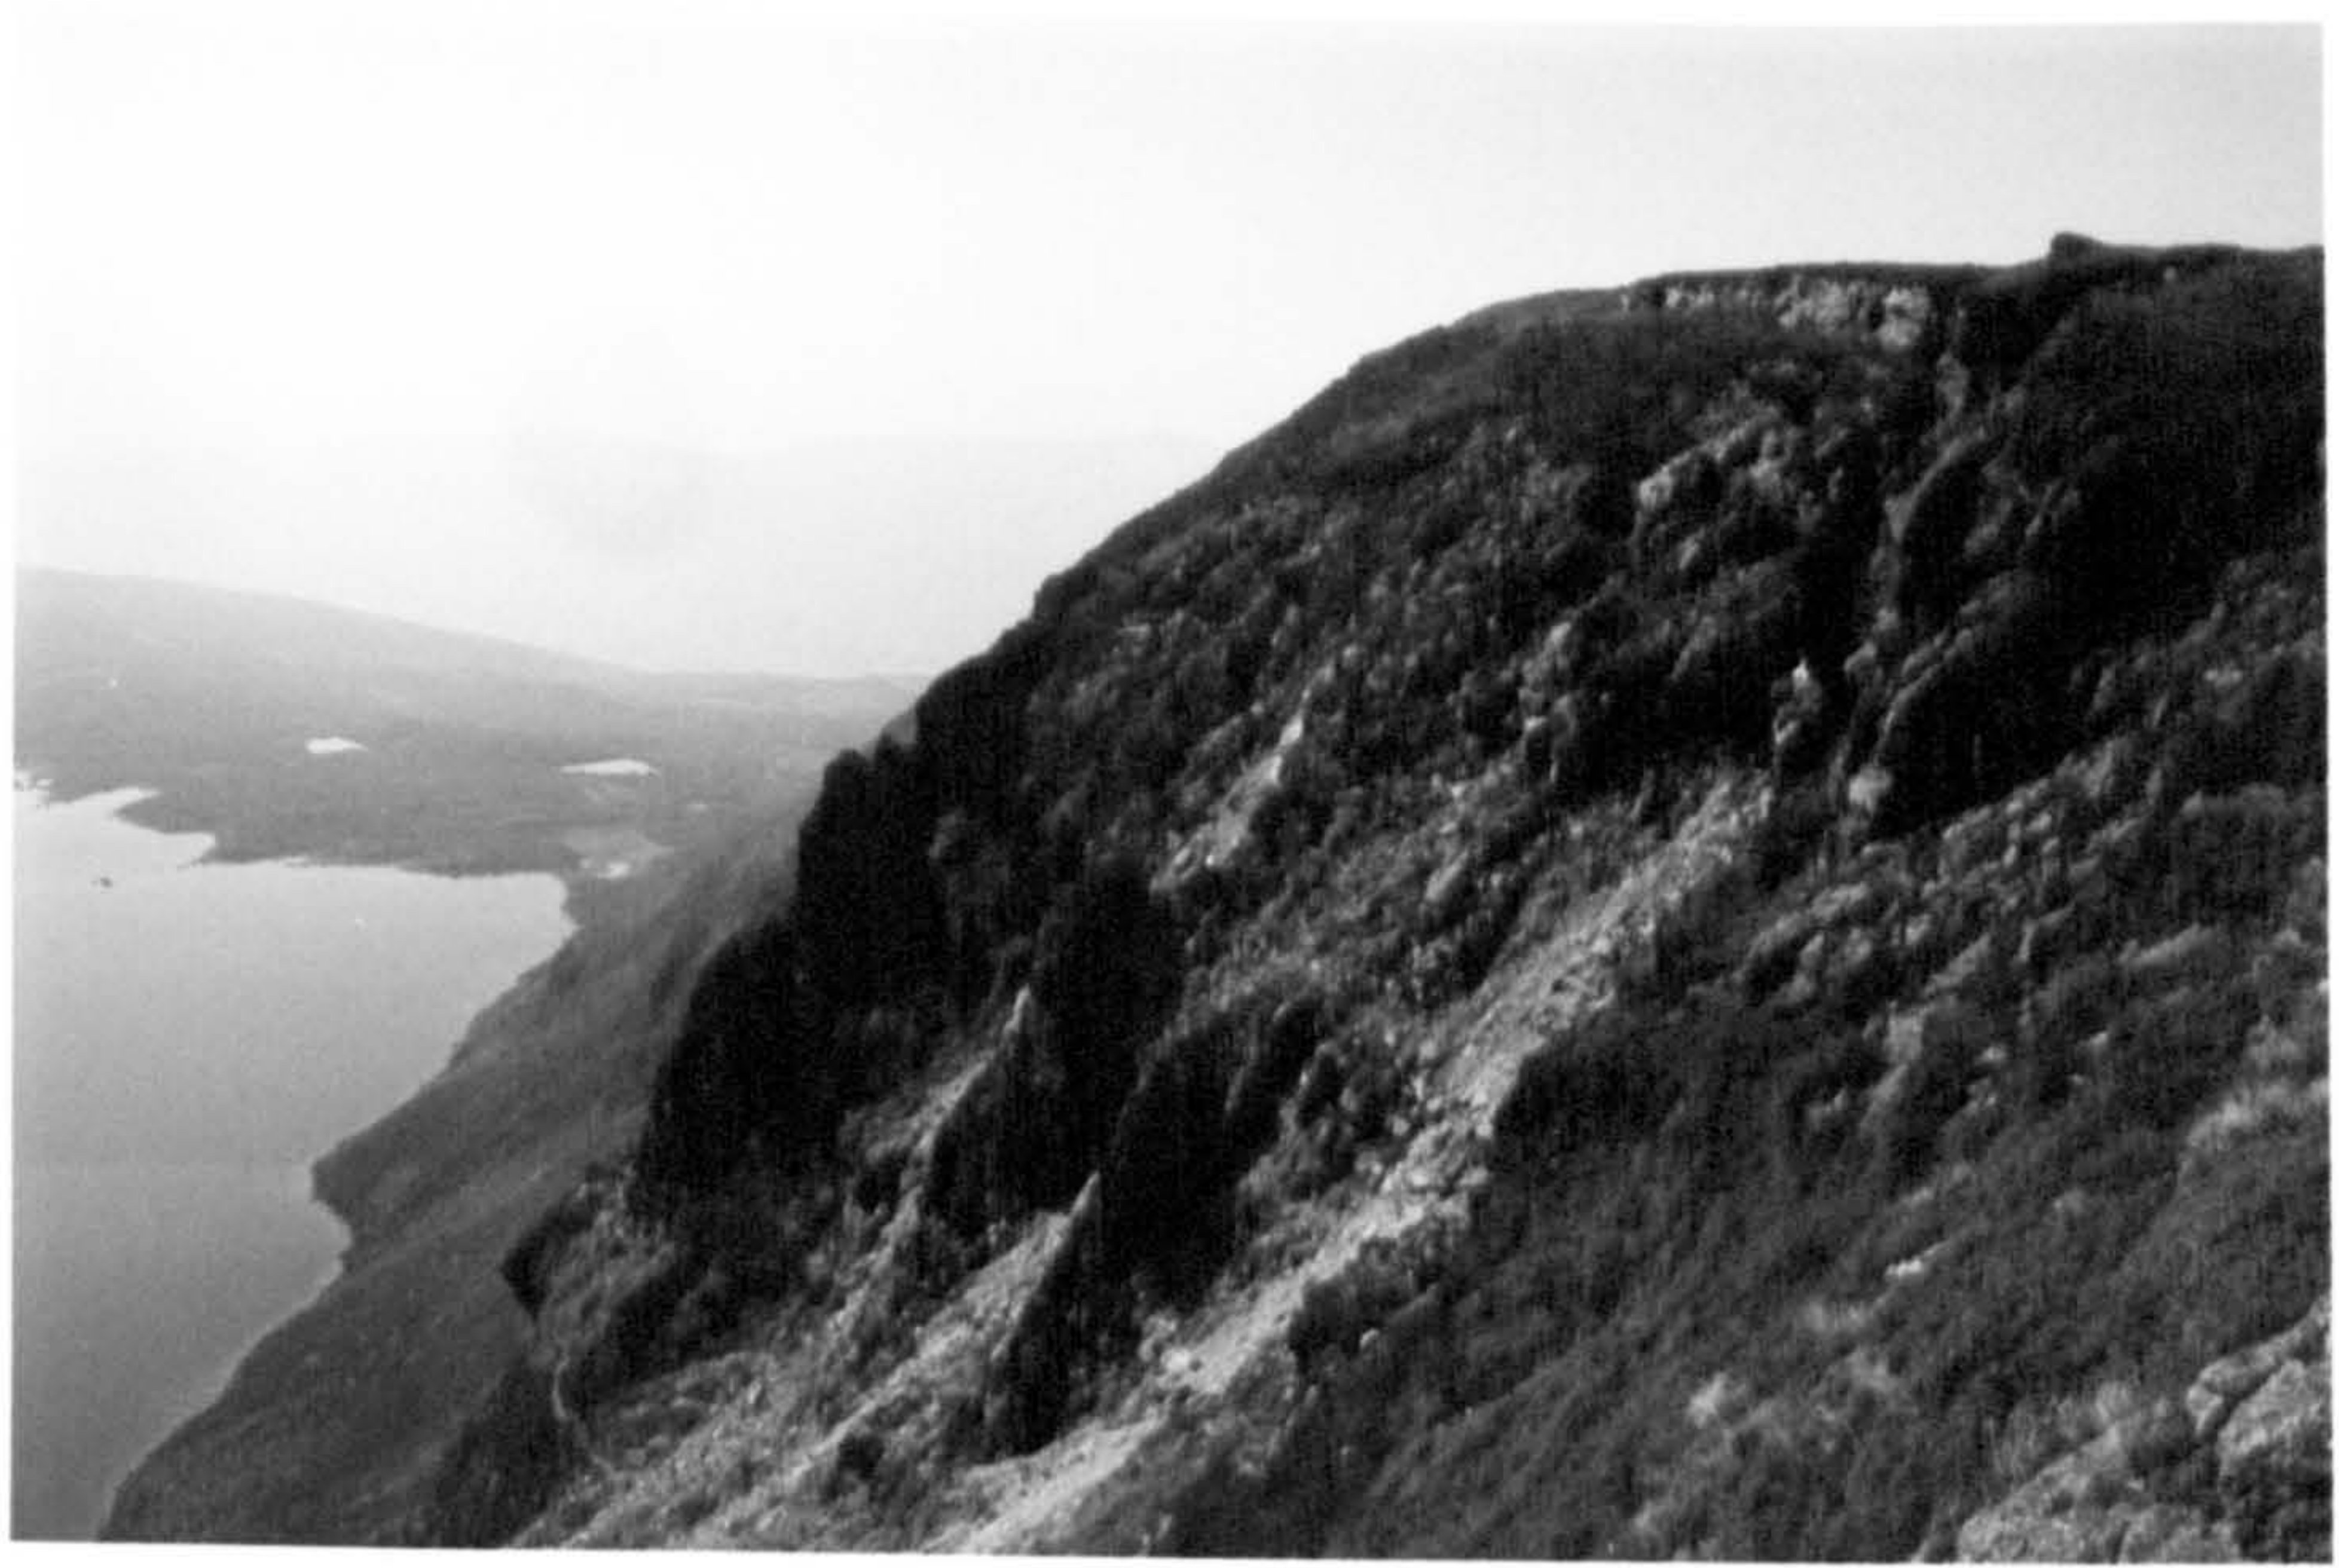
Plate 6.2: The Garbh Choire Mor RSF. The failed-debris is located at the bottom-centre and the scar is sited to centre-right. The large 'ramp' in the centre of the Plate is a debris-less RSF scar.

A large mass of Moinian gneiss boulders, covering c. 17,000 m² of the floor of Garbh Choire Mór, has evidently originated from a planar scar located on the S-facing corrie headwall (Plate 6.2). The debris mass is estimated to be up to 35-m-thick and contains several massive boulders the largest of which exceeds 3,000 m³.

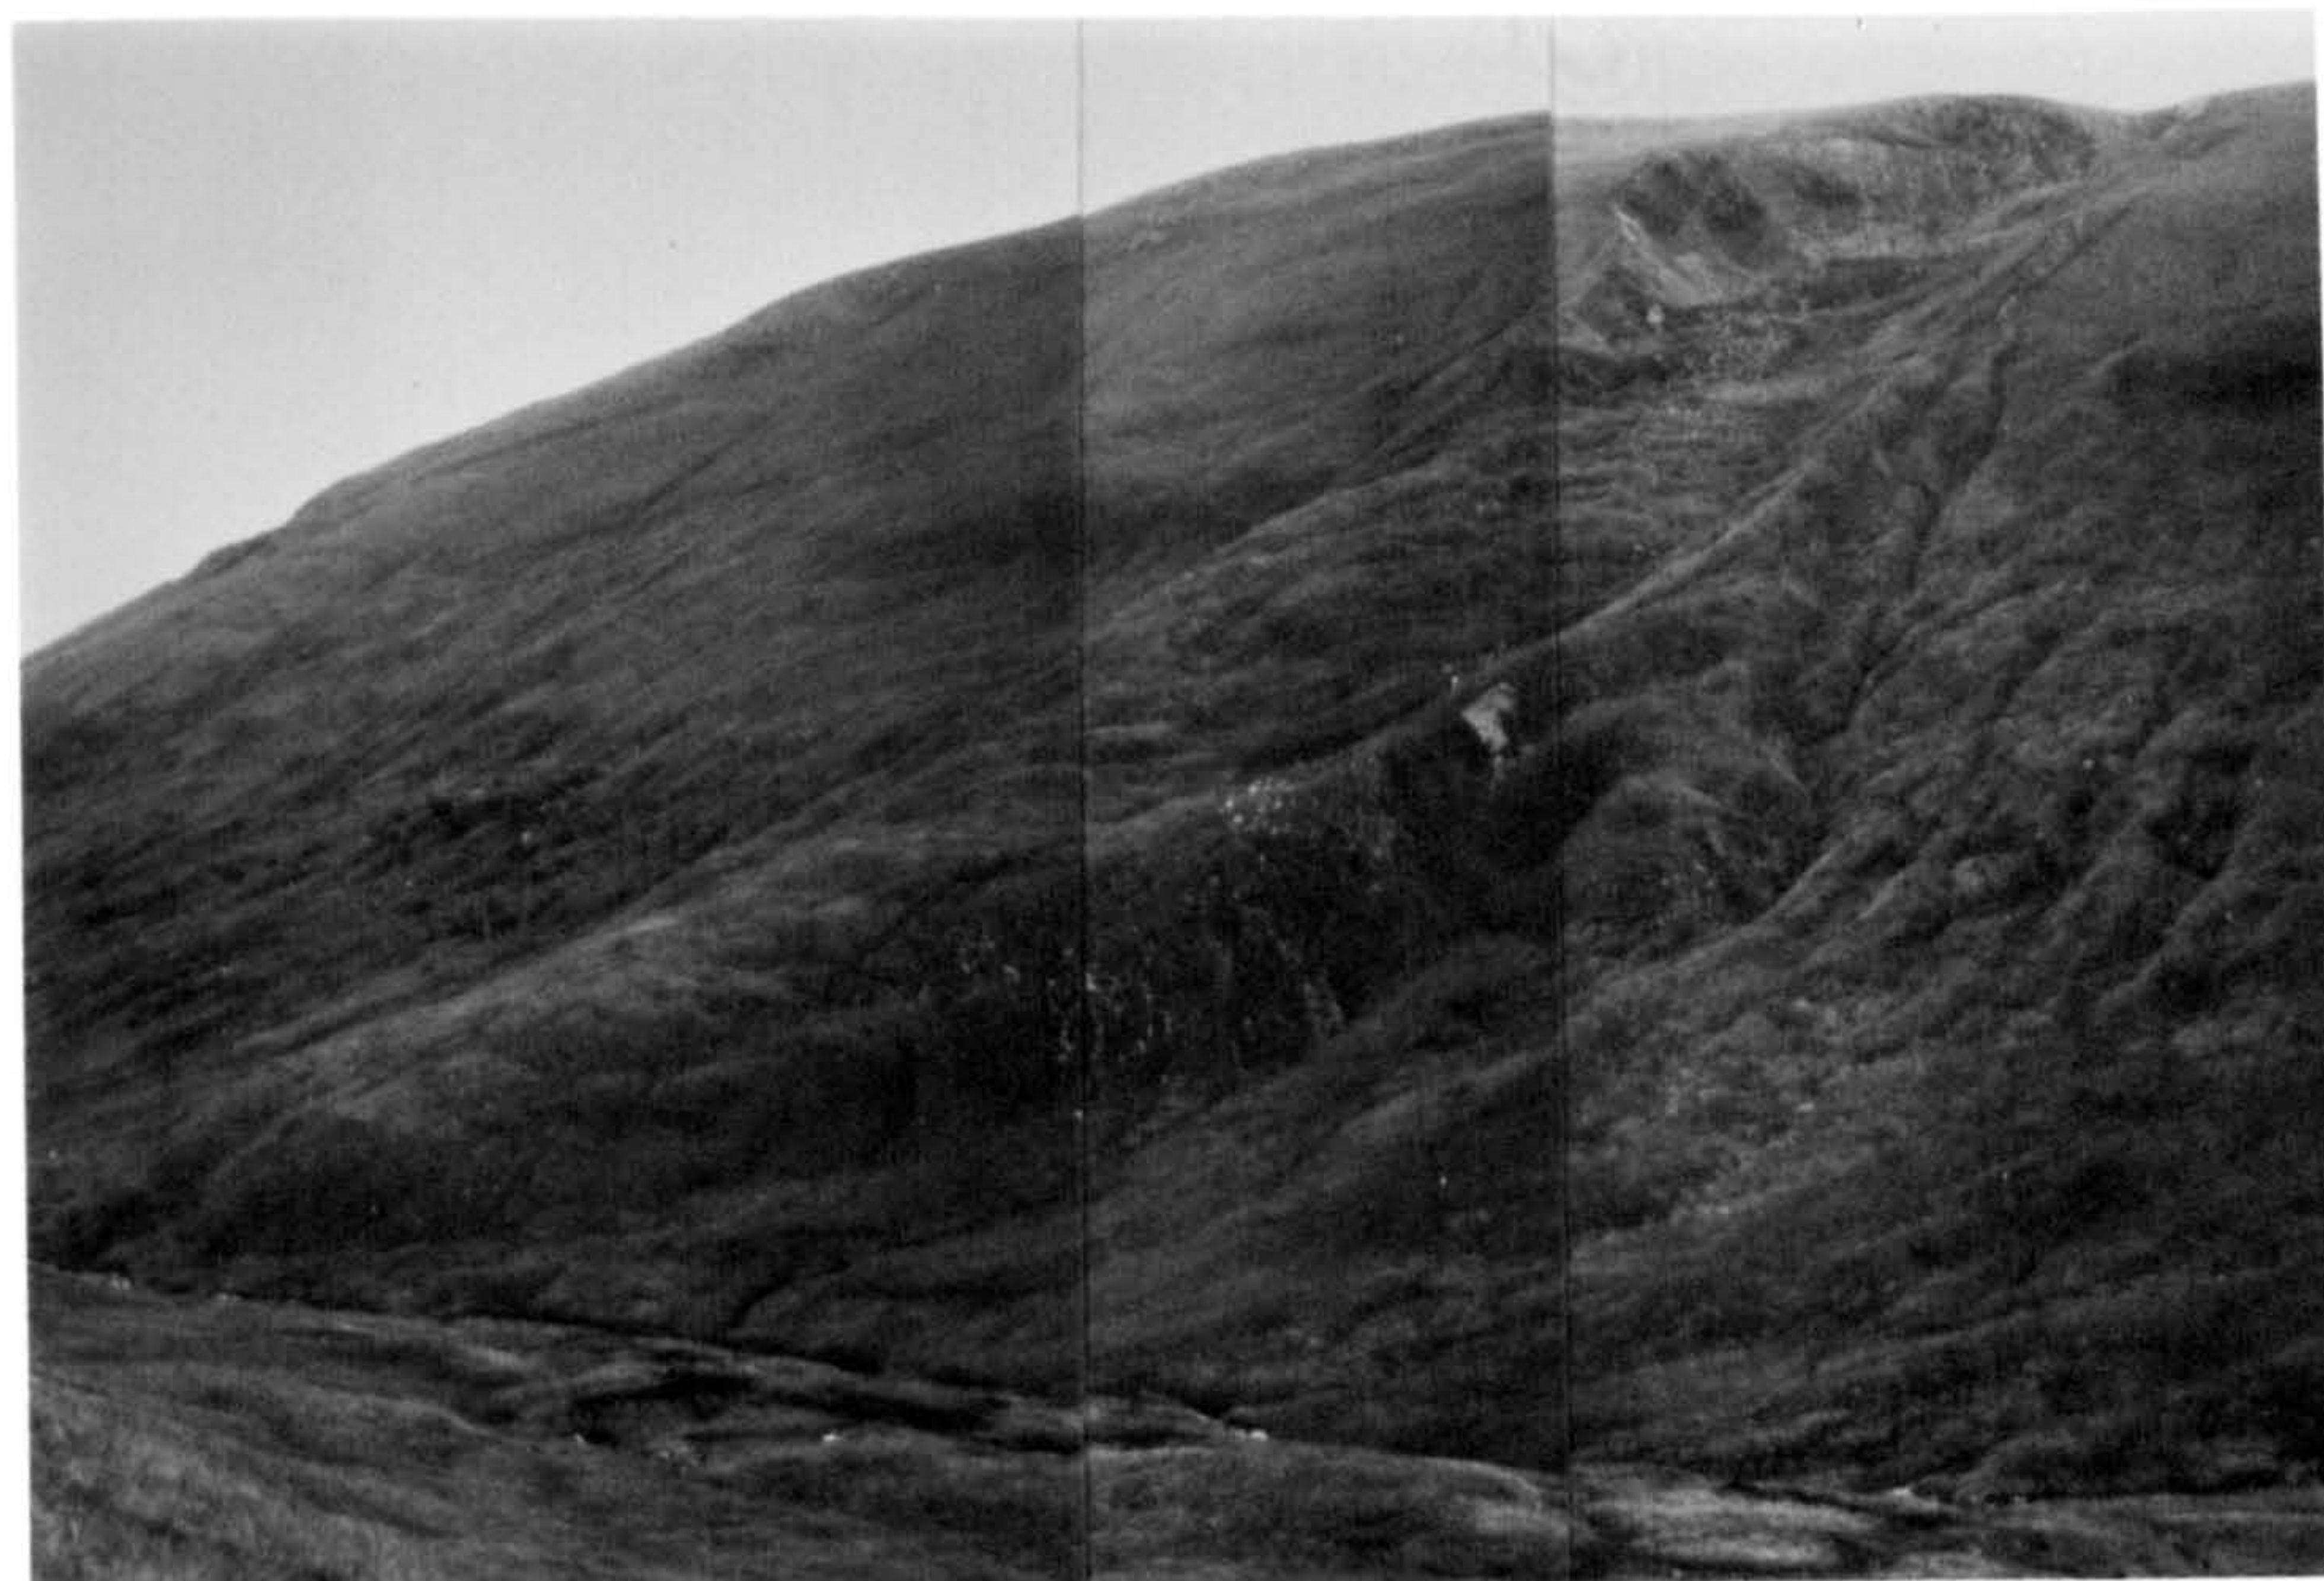
Plate 6.5: The Mullach Fraoch-choire RSF viewed from the SE (note levées and ridges on the feature).

An impressive tongue of psammite rock debris, up to 20-m-thick, dominates the W-facing headwall of Fraoch-choire (Plate 6.5). The

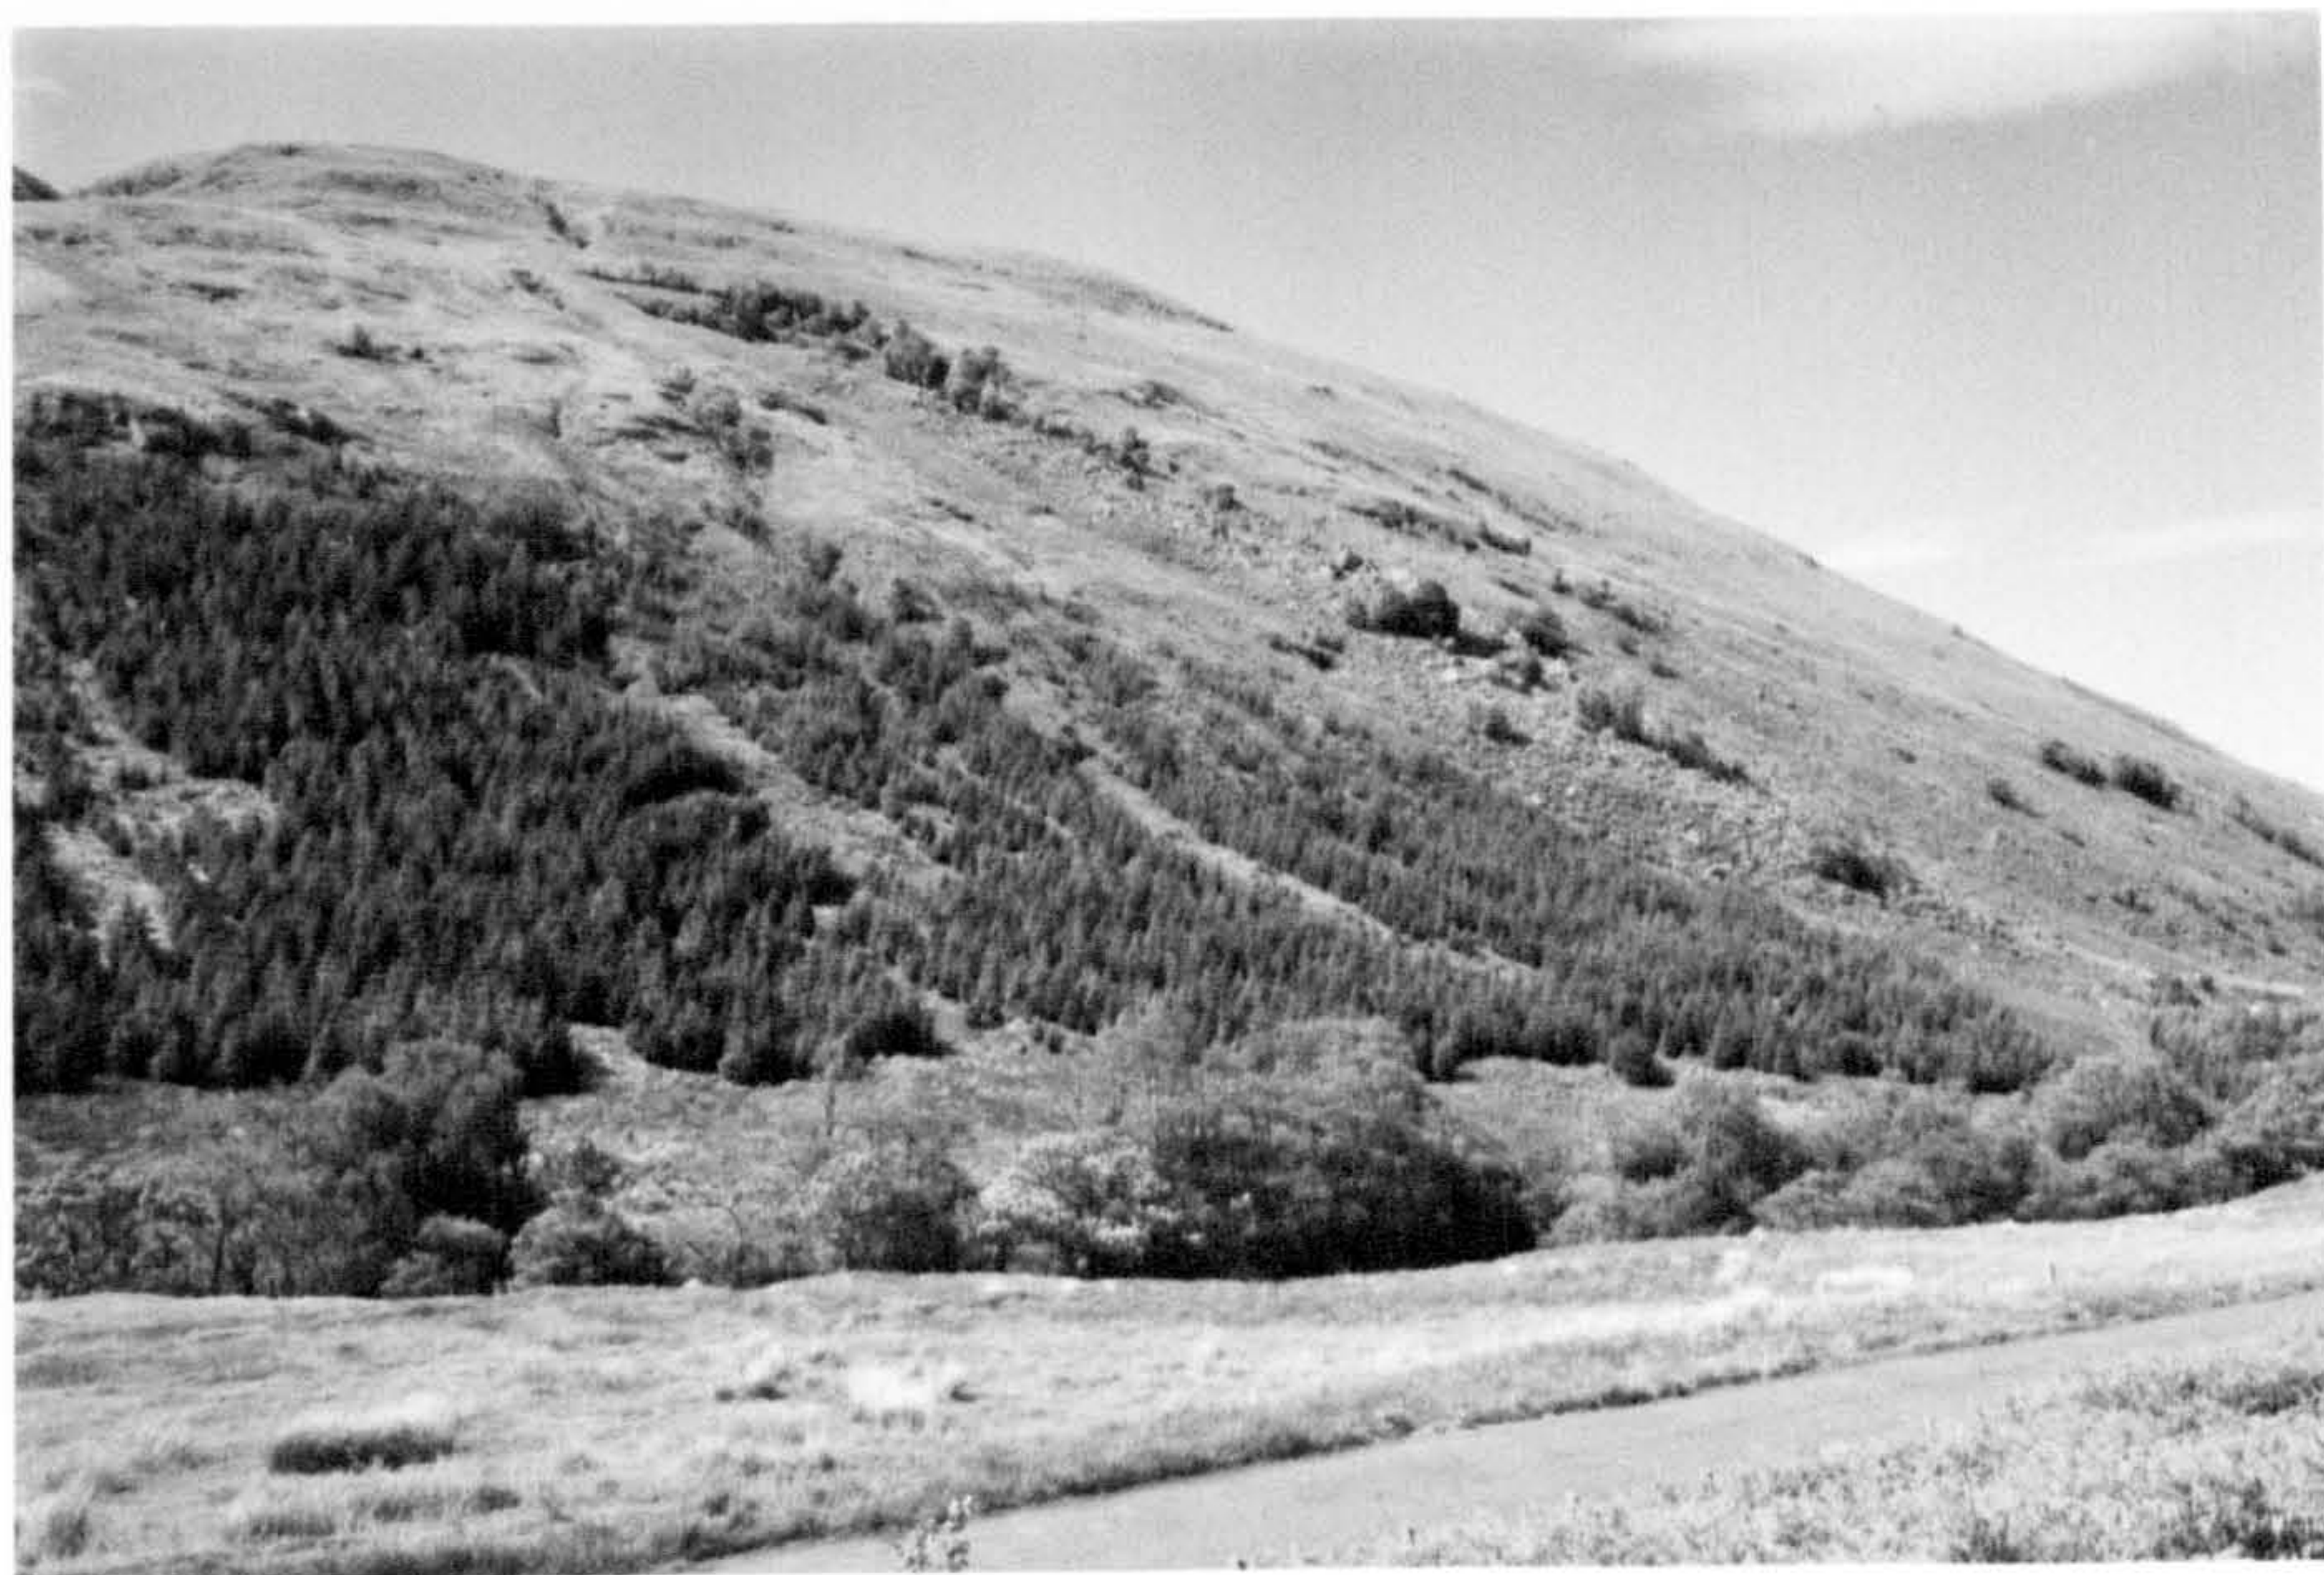
Plate 6.6: The Glen Kinglas RSF viewed from the NE.

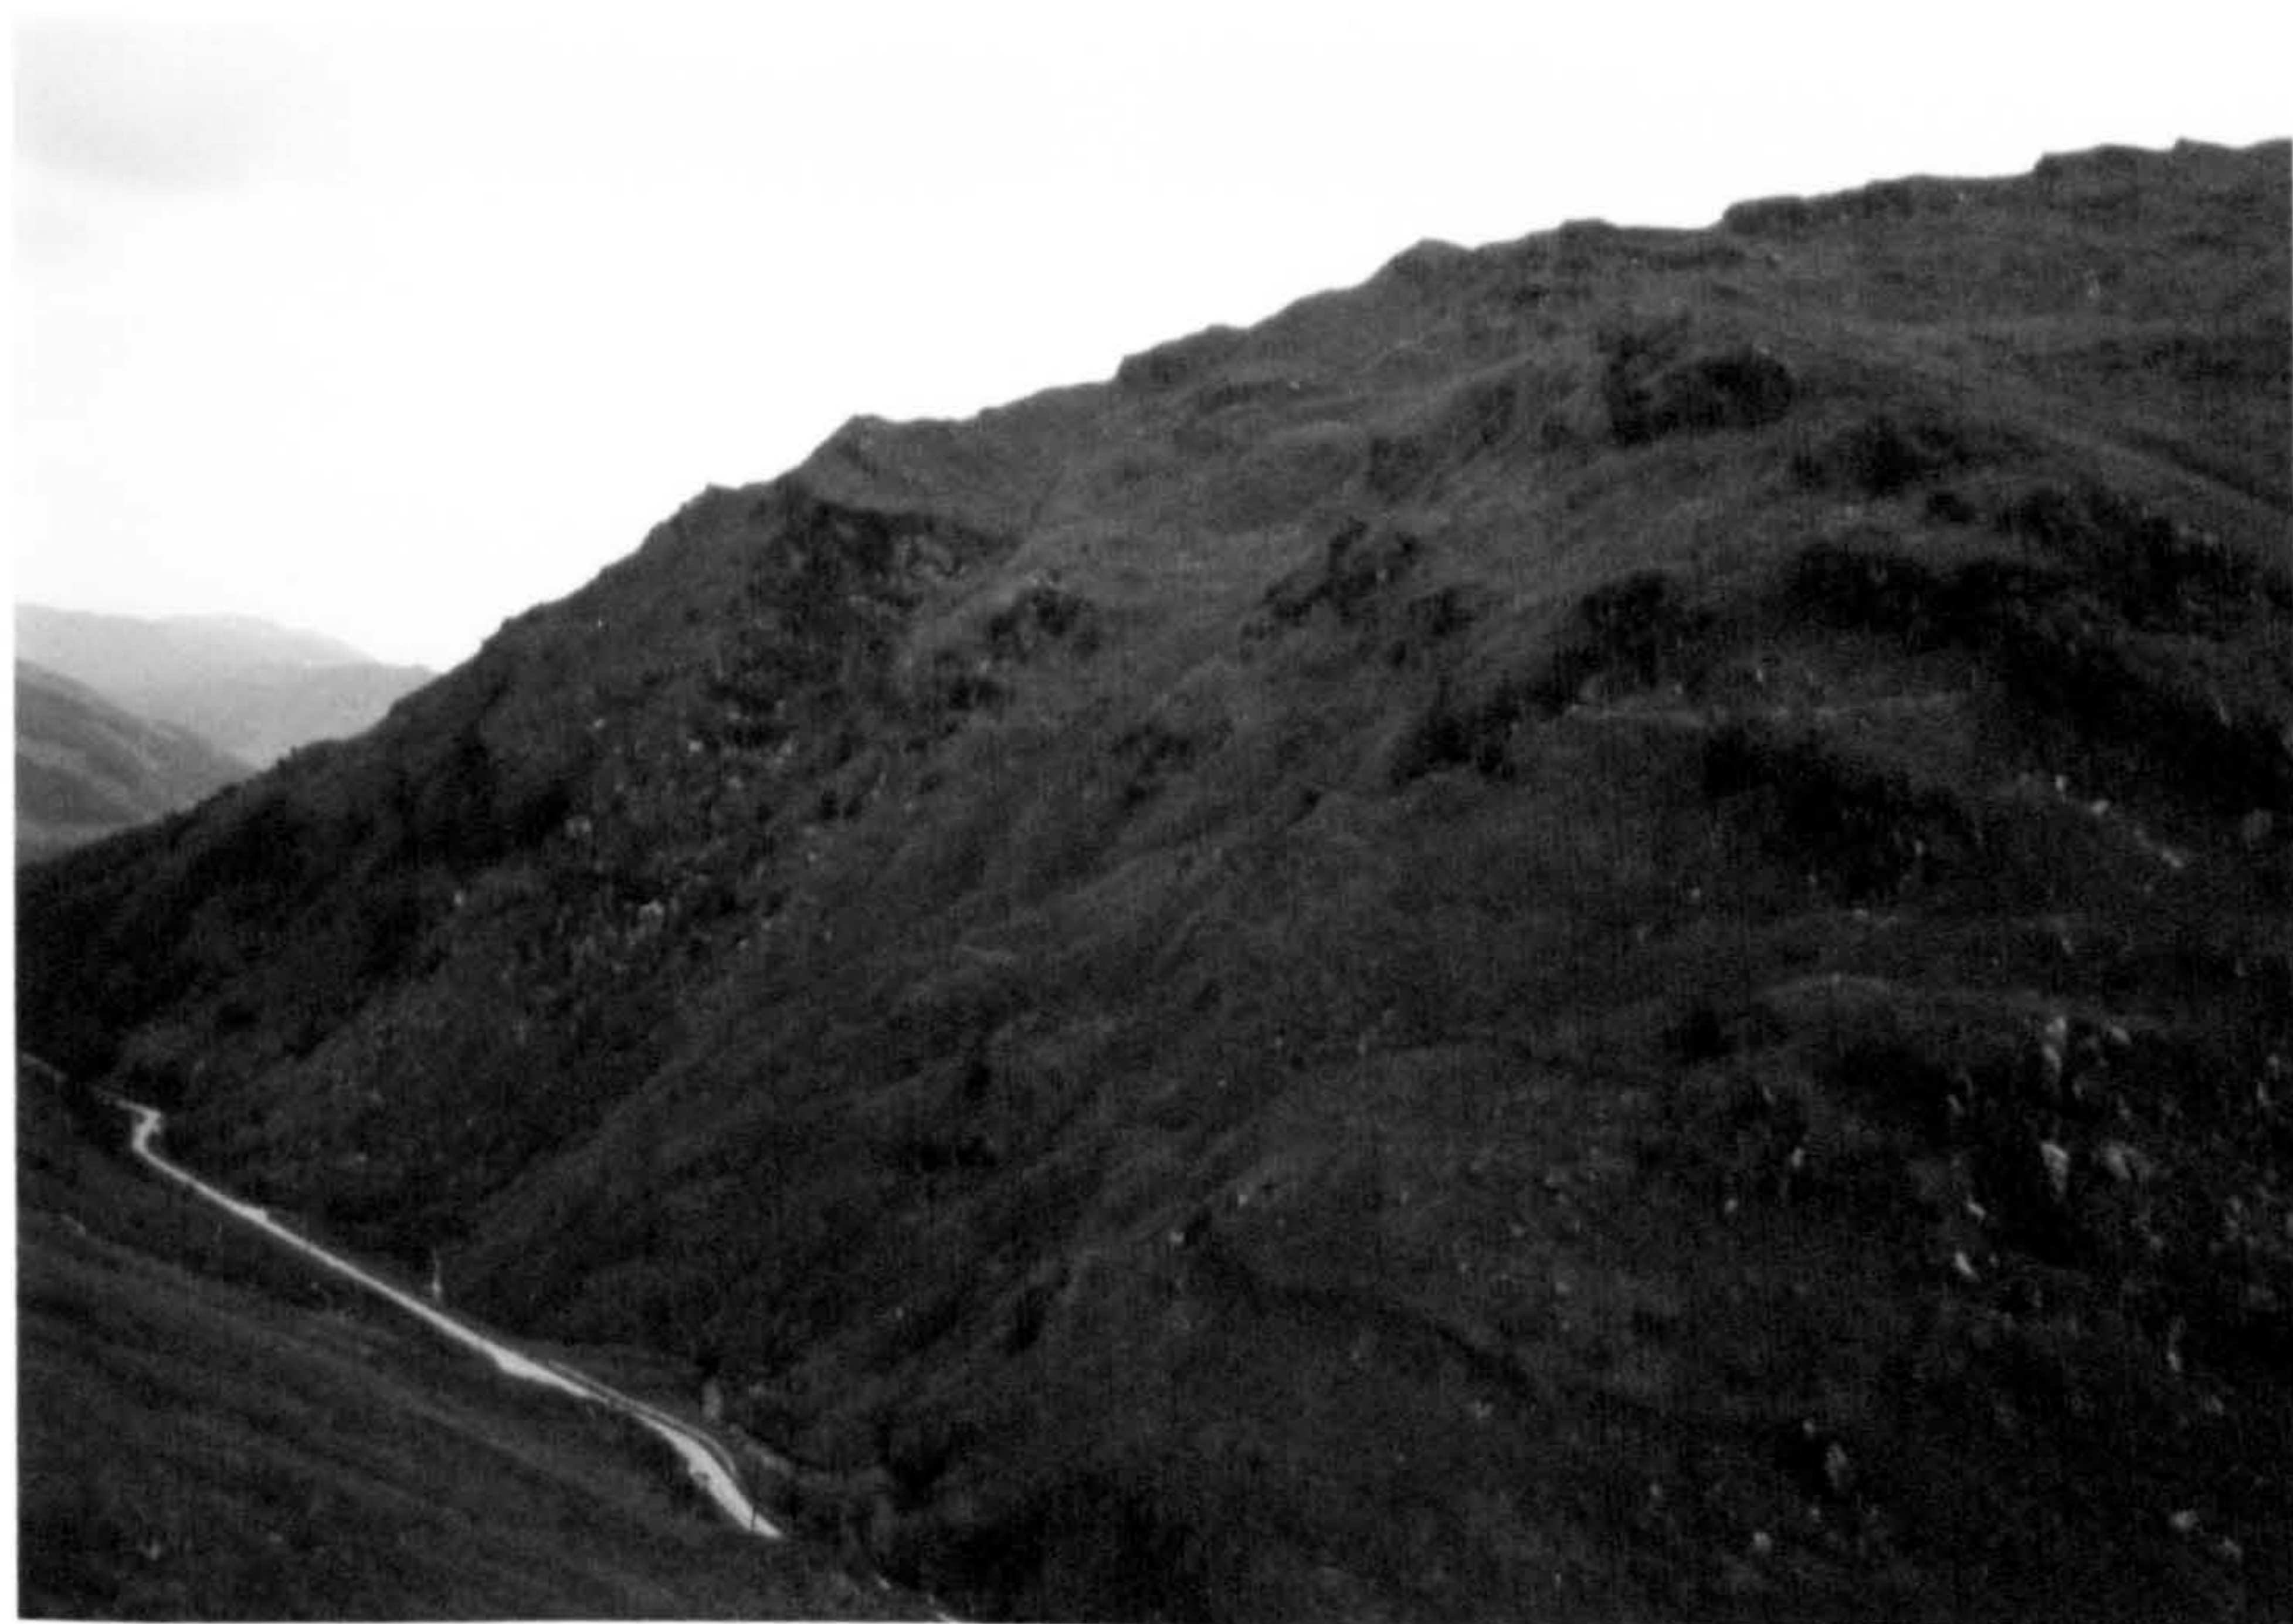
slope angles immediately outside the failed slope area, to be 34° . A cross-section through the slope (Fig. 7.2b) depicts the major block height as 60 m, as estimated by extrapolating lines from the rear-scarp and the upslope-wall of the toppled block until they intersect.

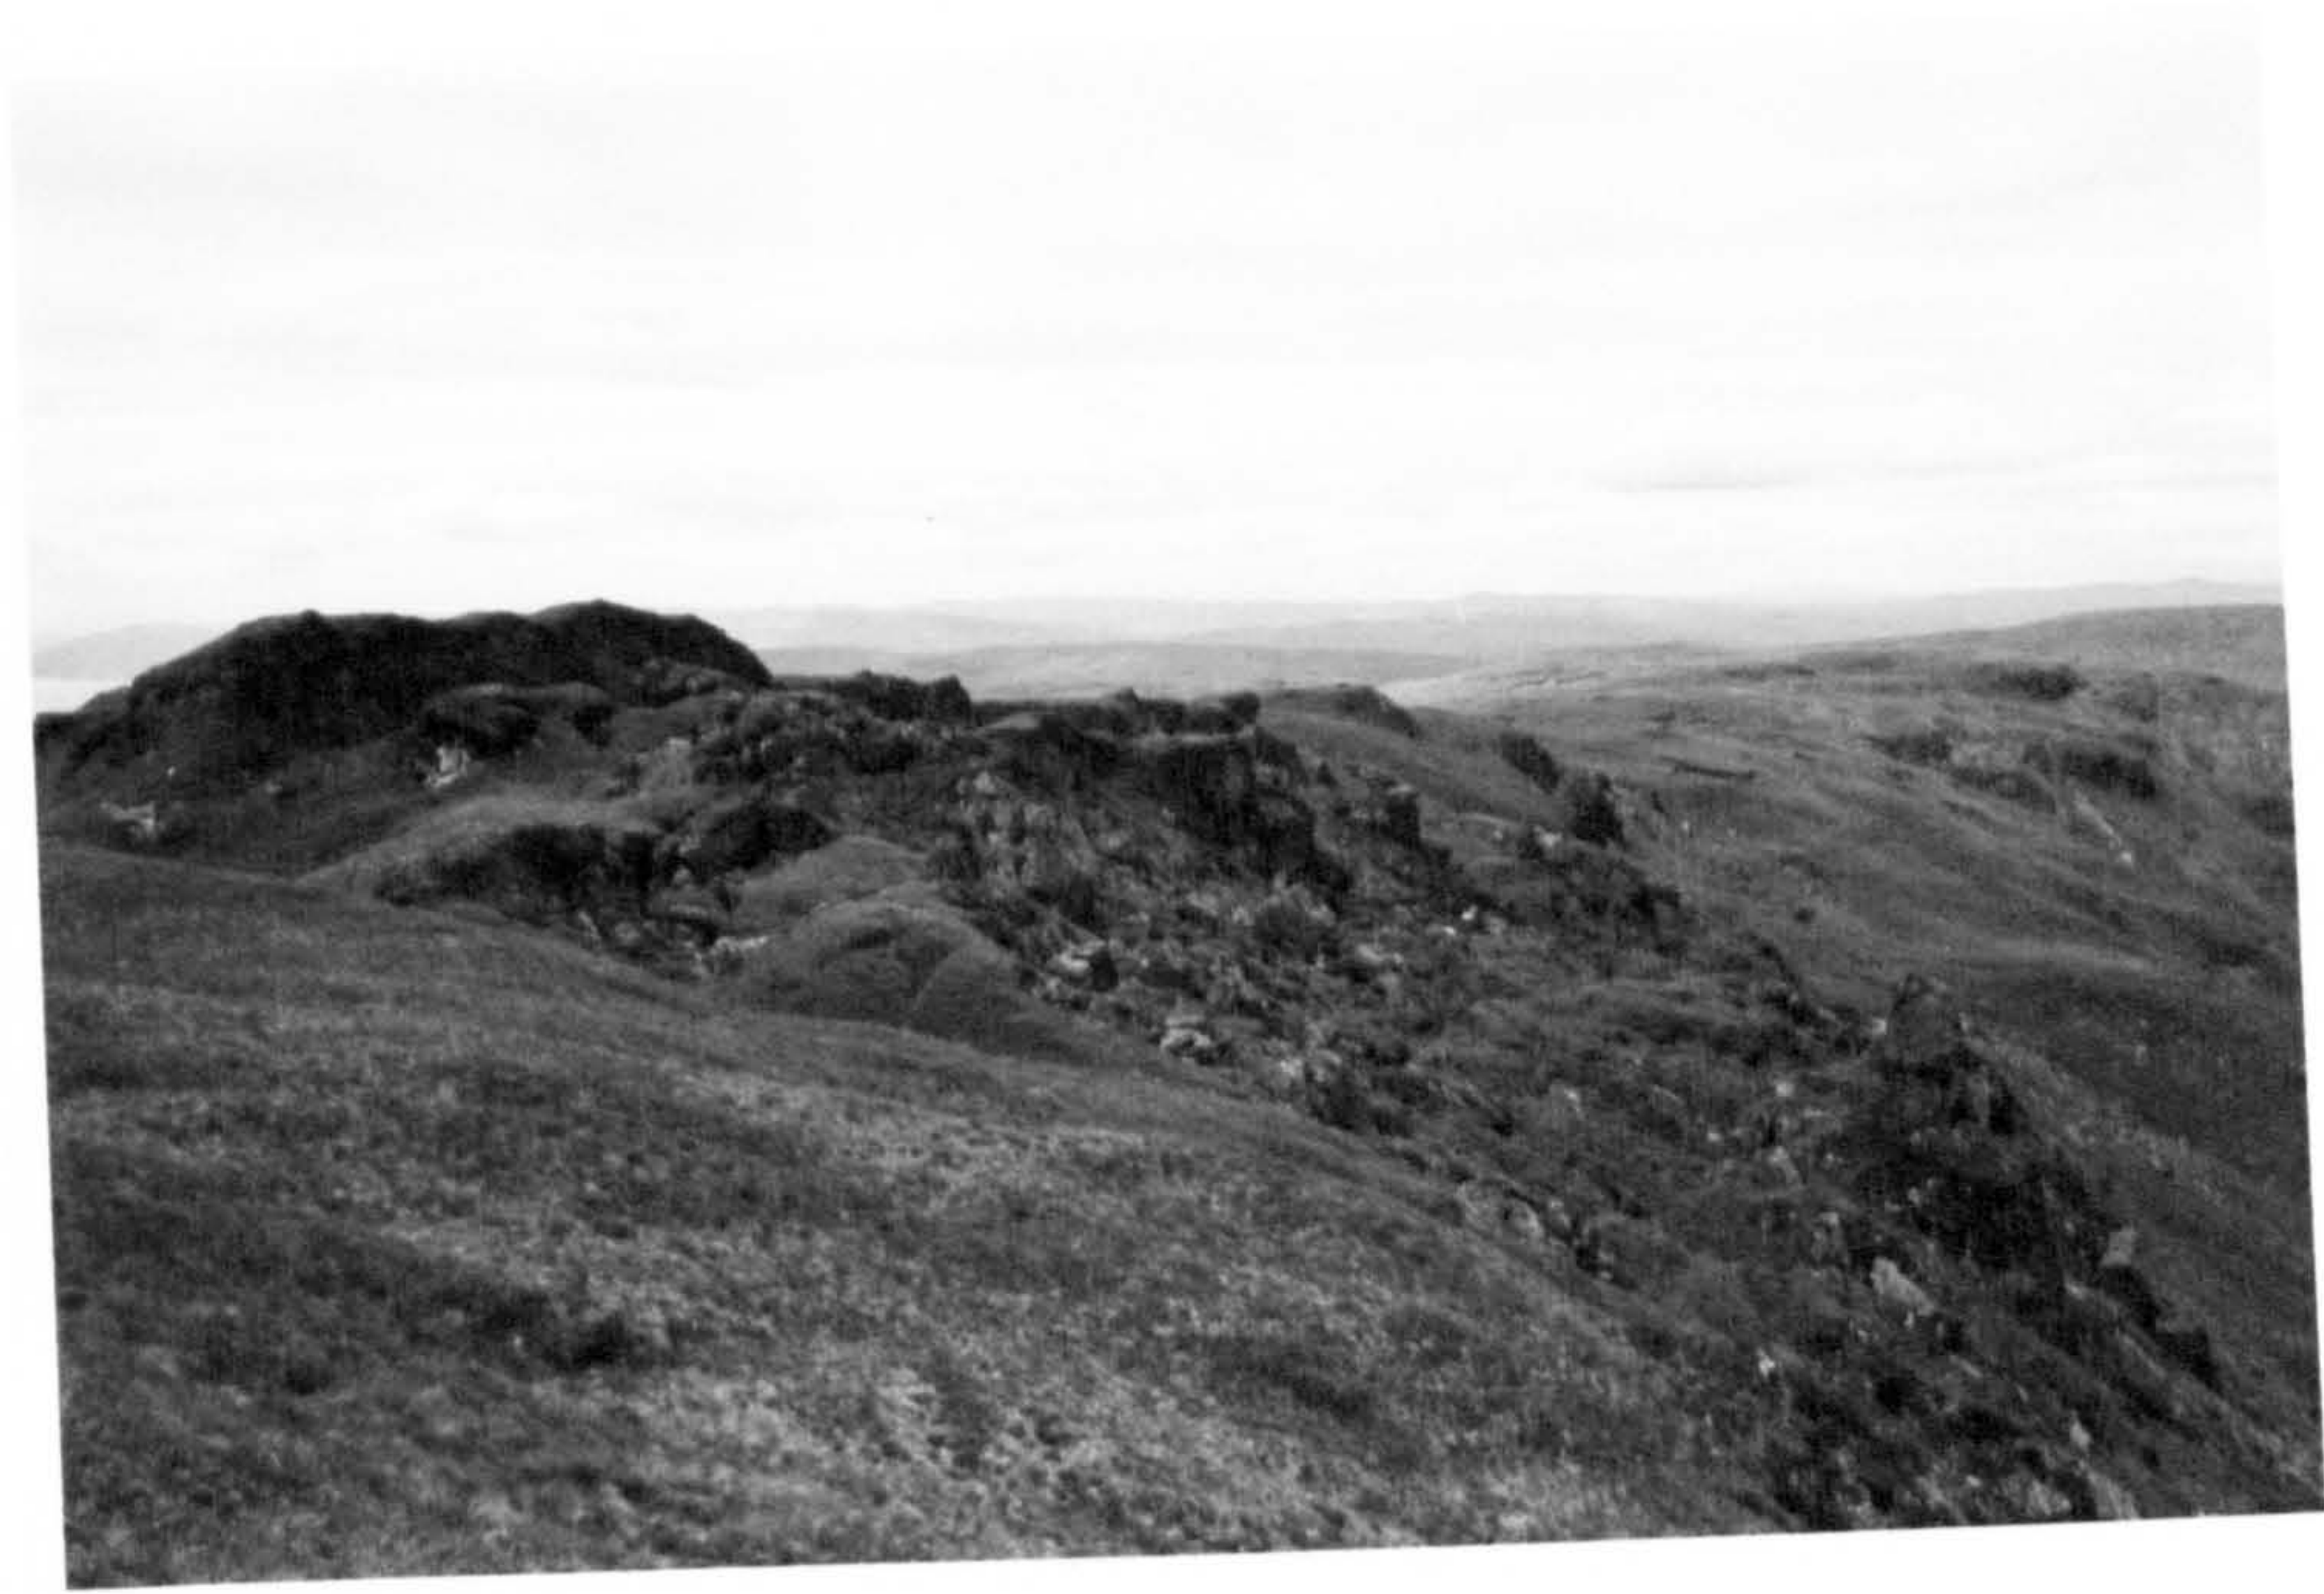
Plate 7.3: The slope trench located between the uppermost toppled block and the rear-scarp at Mullach Choire a' Chuir. The rear-scarp is c. 8-m-high.

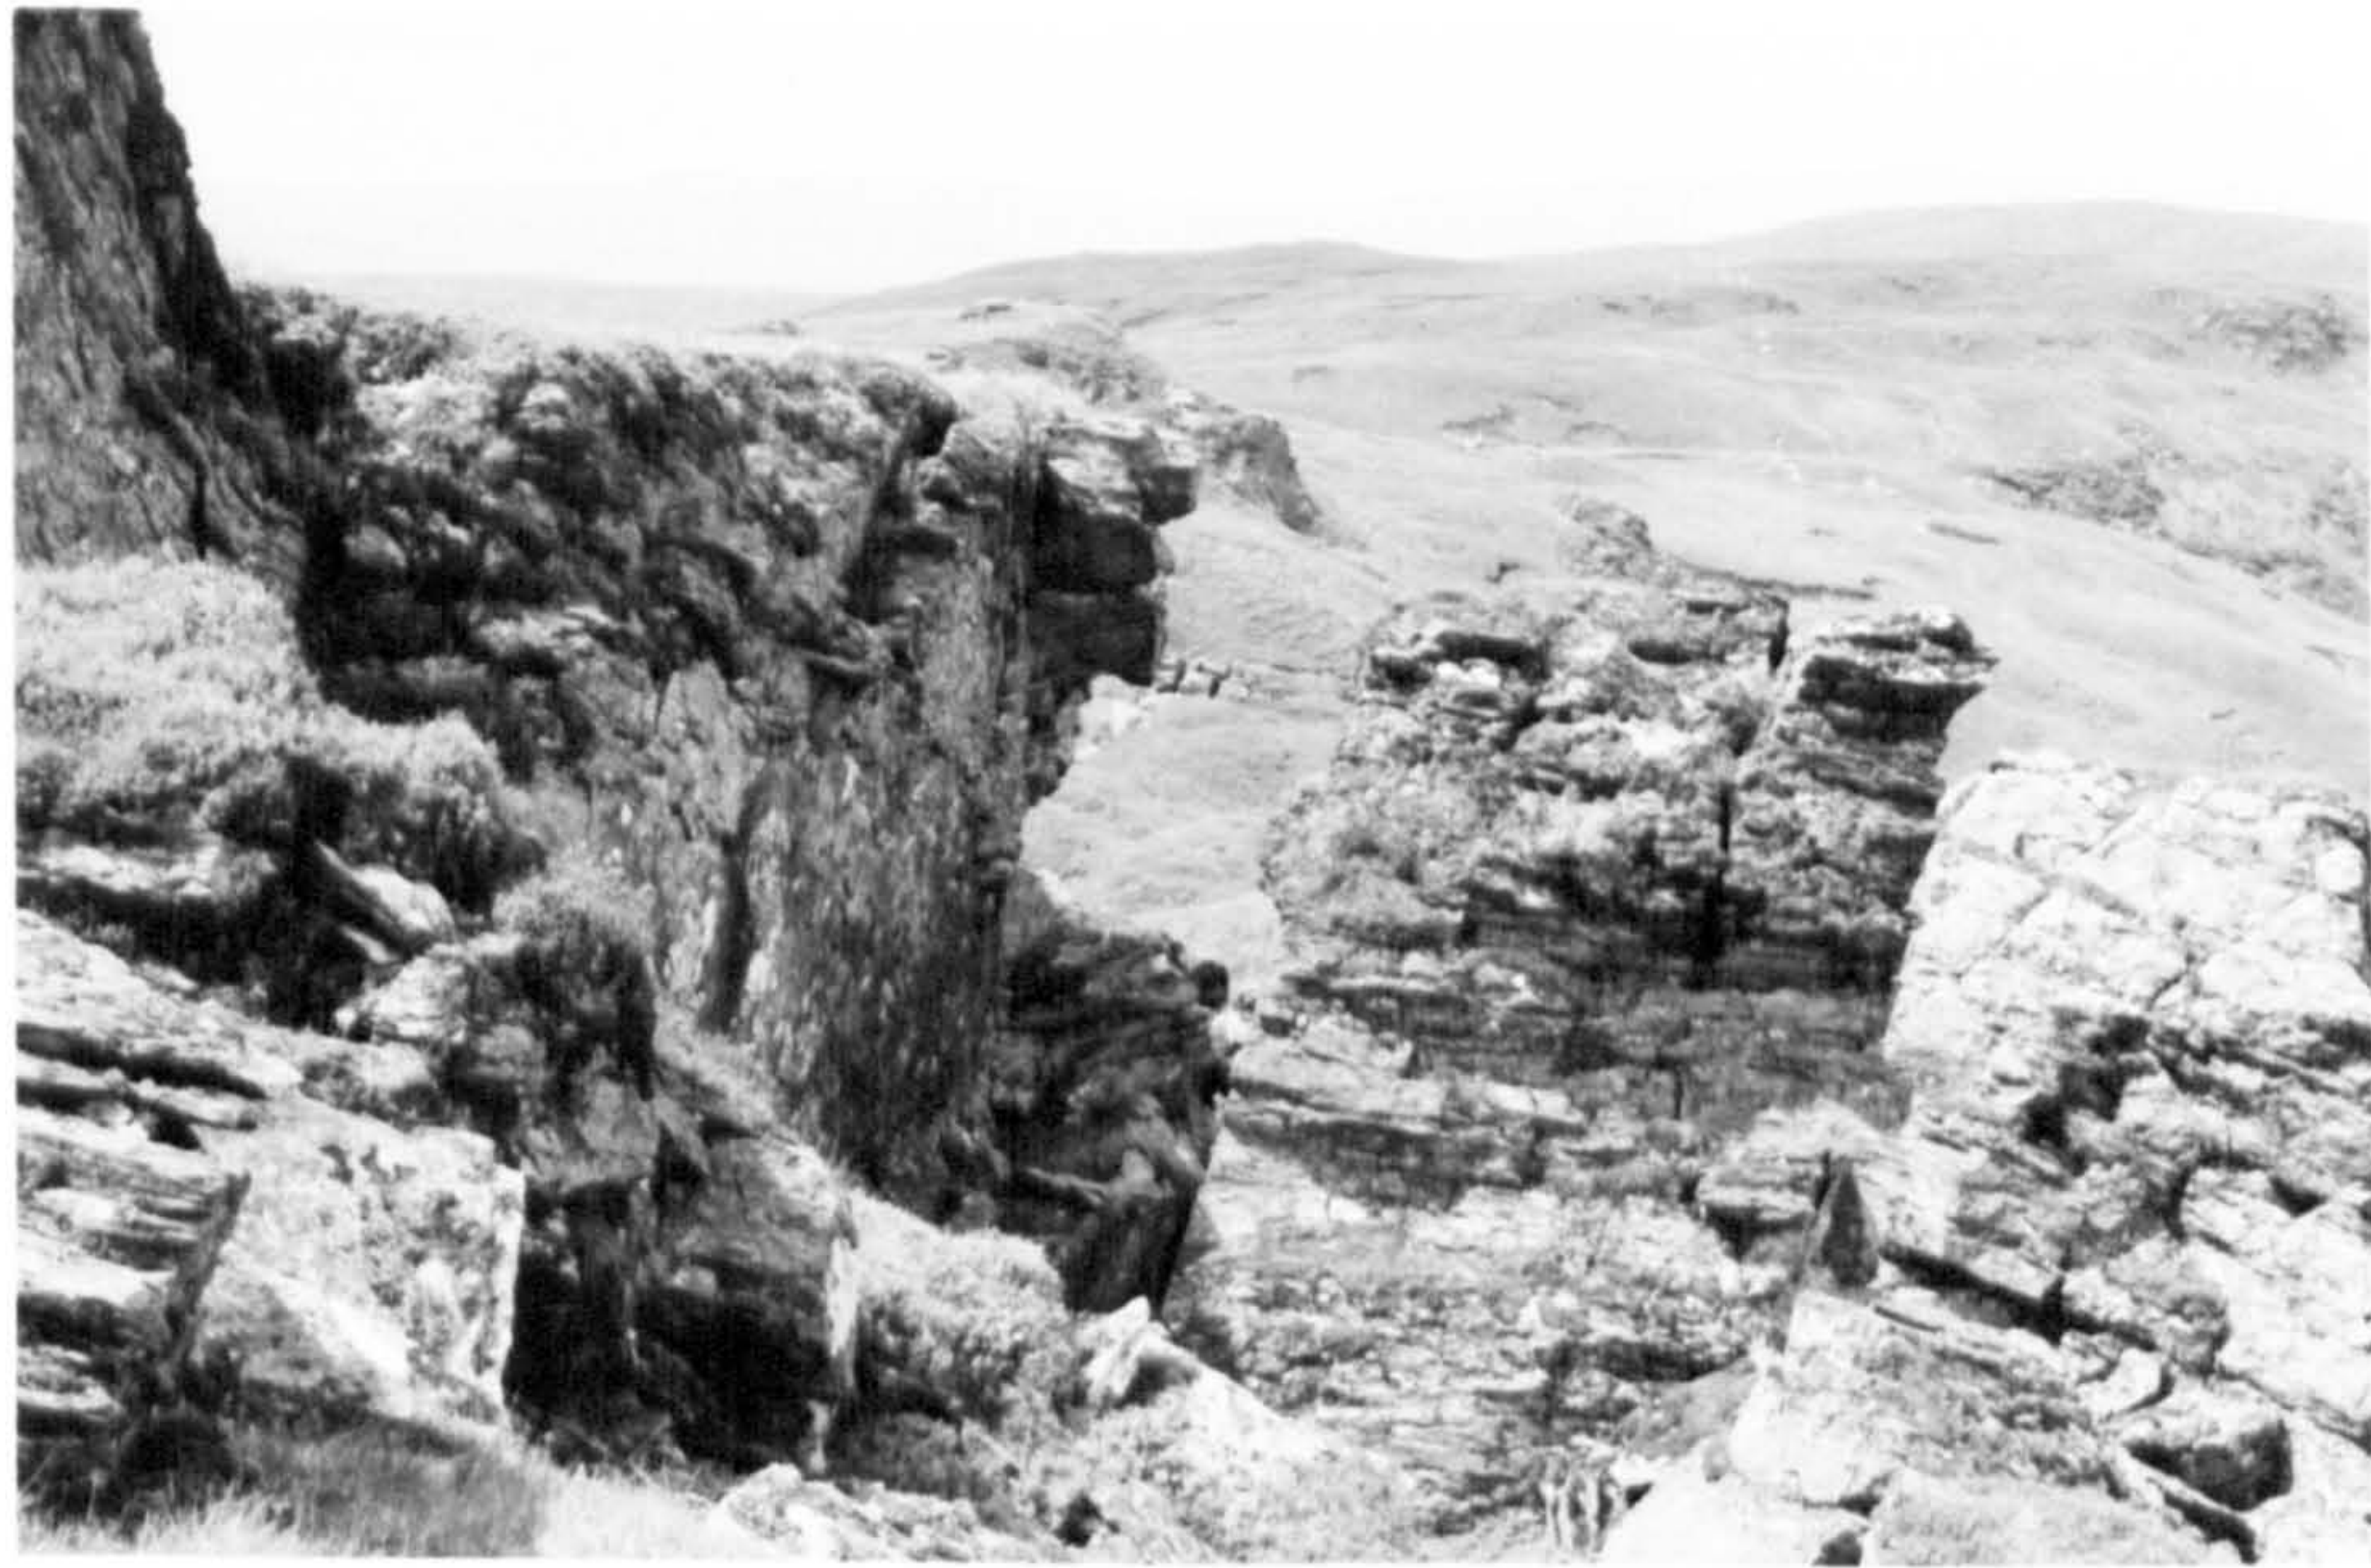
Plate 7.4: Translated blocks in the centre of the Mullach Choire a' Chuir RSF. The tension-crack is c. 3-m-wide and the blocks are up to 9-m-high.
